Hybrid Human-Artificial Intelligence Approach for Pavement Distress Assessment (PICUCHA)

Stavební Obzor – The Civil Engineering Journal

Reus Salini Bugao Xu Regis Carvalho

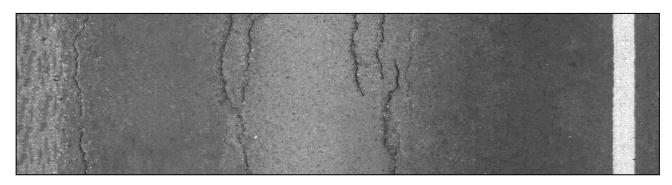
Figure 3 shows the image used in this study. It has 2048 x 512 pixels and 256 gray scale color scheme, covering an area of approximately 3.6 x 0.9 meters, that are the characteristics of the most widely used cameras nowadays, with line scan technology. The picture shows different patterns including raveling, good pavement, cracked pavement and a white strip. Figure 4 shows the pixels coordinates represented as a 3D mesh of points with artificial colors where the pixel color distribution over the picture surface can be seen.

Figure 3 - Analyzed pavement picture with 2048 x 512 pixels
